The Columbia Accident: Synopsis of CAIB Report* Regarding the Physical Cause of the Accident and and Personal Thoughts

James O. Arnold, Ph.D

***Seminar based on CAIB Appendix F2, Vol IV
by J. O. Arnold, H. E. Goldstein and D. J. Rigali**

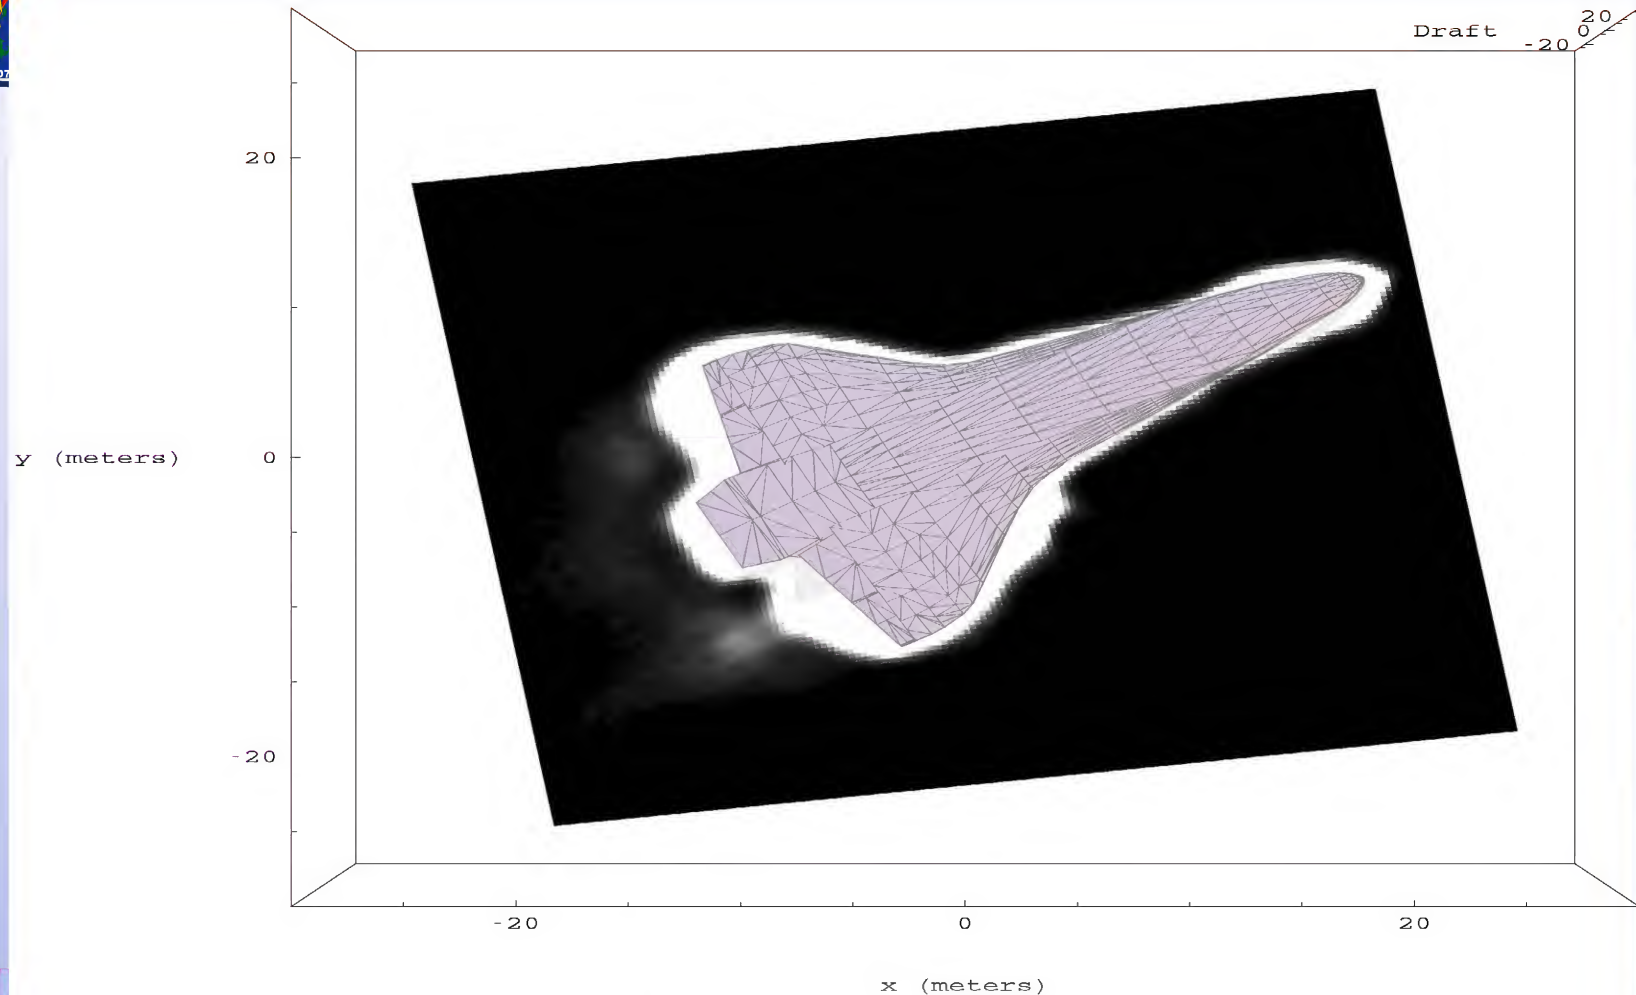
Starfire Photo from Kirtland AFB GMT13:57:14

Starfire Optical Range Image (26 March 2003)
model overlay (R. Cleis, R. Fugate, R. Johnson)
image sharpened using deconvolution (J. Christou)

The model scaling and orientation are based on telemetry (latitude, longitude, and altitude from NASA) and observations (azimuth, elevation, and range from SOR). The image scaling and orientation were derived from measurements using star fields. The Columbia model was provided by NASA.

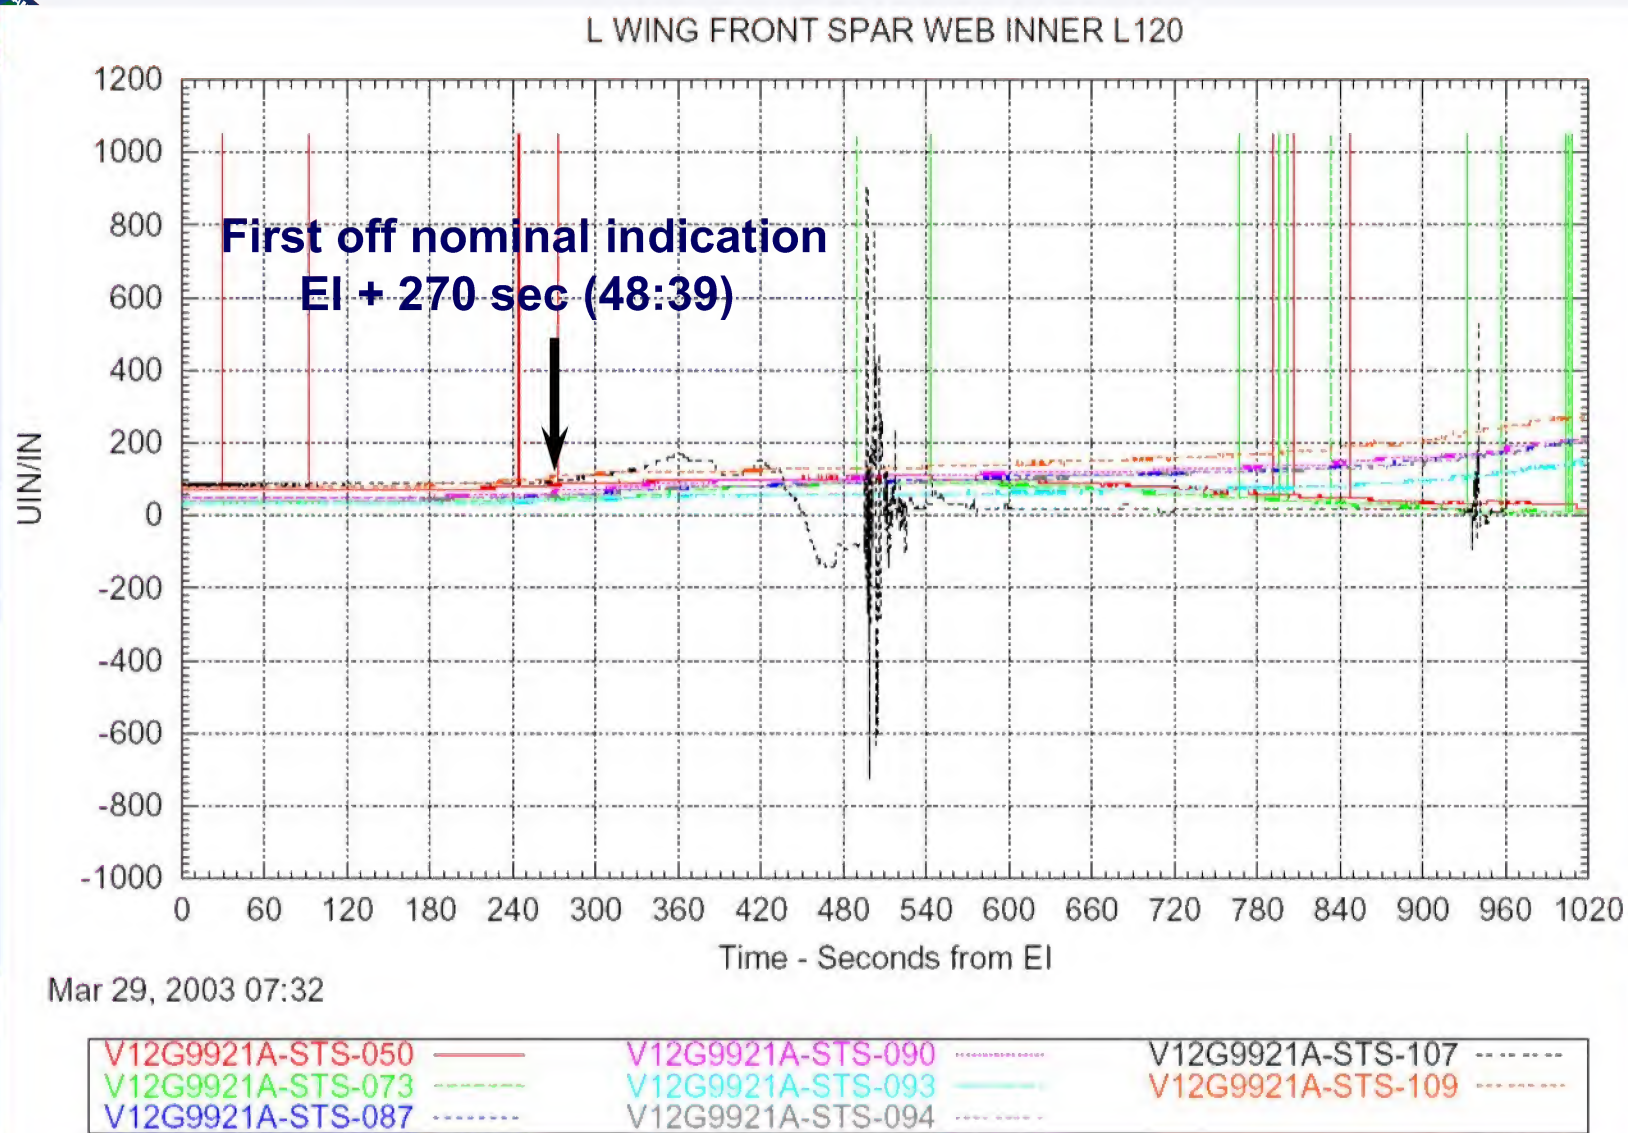
OEX STS-107 Flight Data

48:39 (EI+270 seconds) RCC panel 9 spar insulator strain gage (V12G9921) shows off nominal increase. Thermal stresses build due to the breach in the wing and hot gas impingement on the spar. Pressure also starts to build in the RCC wing cavity adding to the load on the spar. All these loads combine and put an off nominal strain on the spar. Fig. 10

48:59 (EI+290 seconds) Hot gas continues to flow into the RCC cavity through the damaged RCC panel 8. Heat entering RCC cavity is first registered by the temp sensor (RTD) on RCC panel 9/10 clevis fitting (V09T9910). Fig. 11

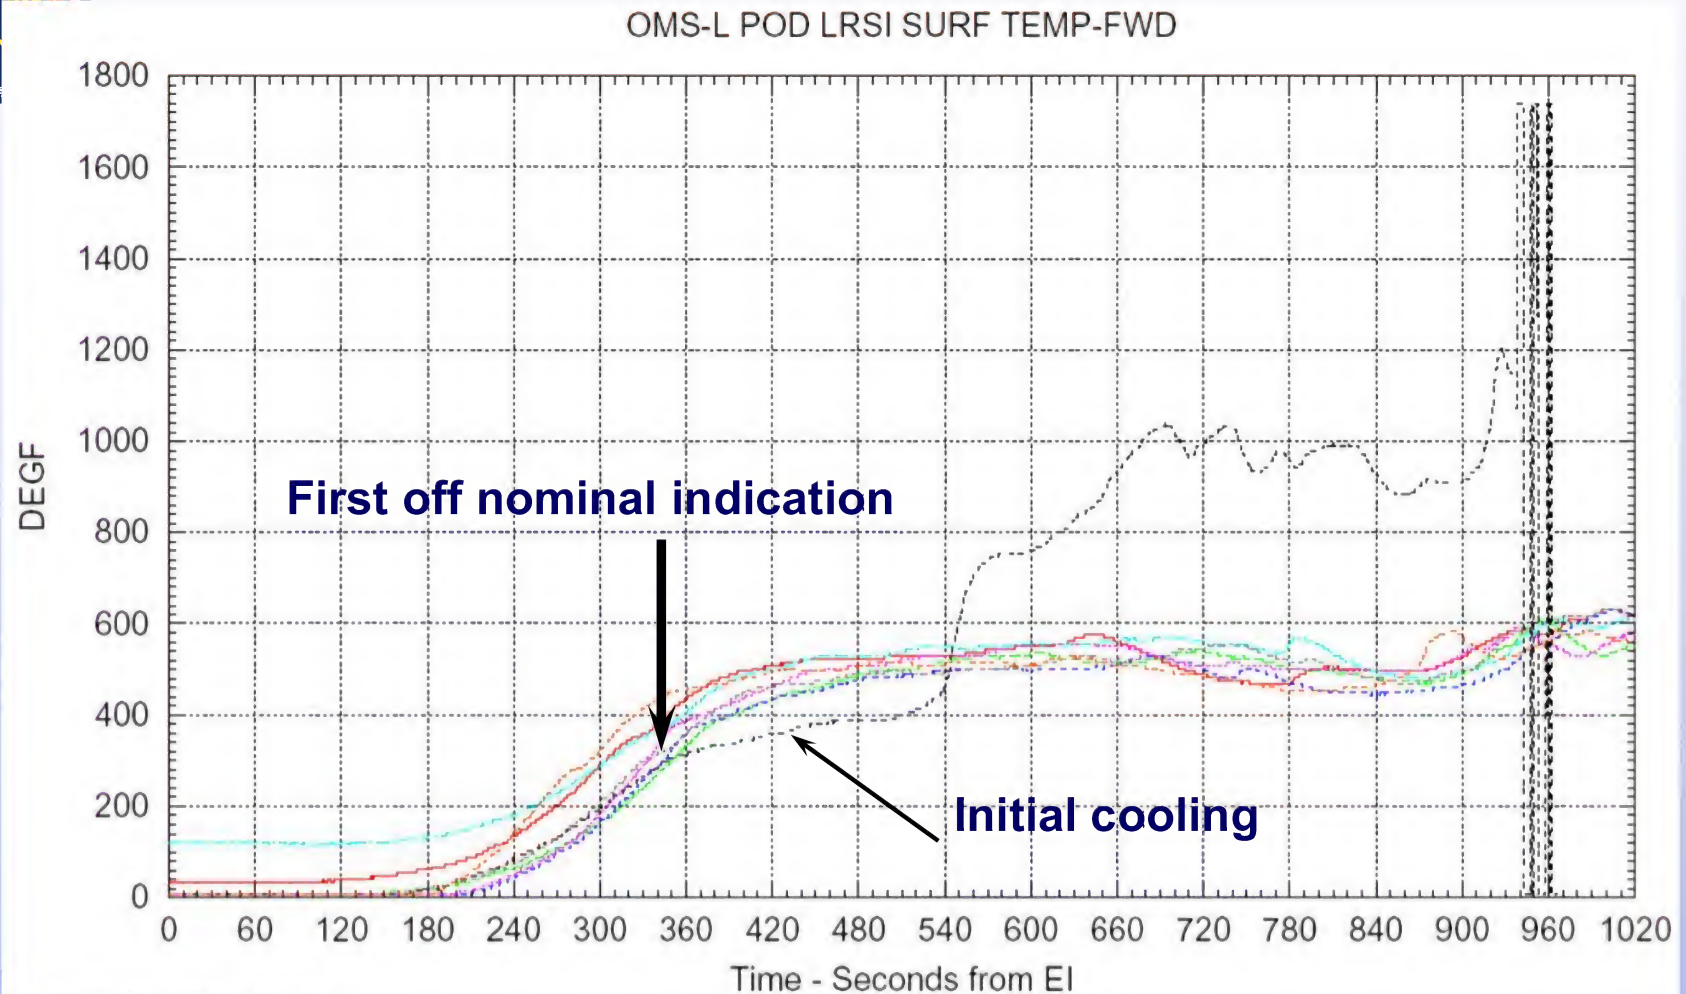
“Typical” Off Nominal OMS Pod Temps.

LaRC Wind Tunnel Tests Data help explain cooling trends on OMS pod

49:49 (EI+340 seconds) OMS pod temperatures initially become cooler than nominal due to leading edge RCC panel damage, as confirmed by LaRC wind tunnel tests. Figs 12 and 13

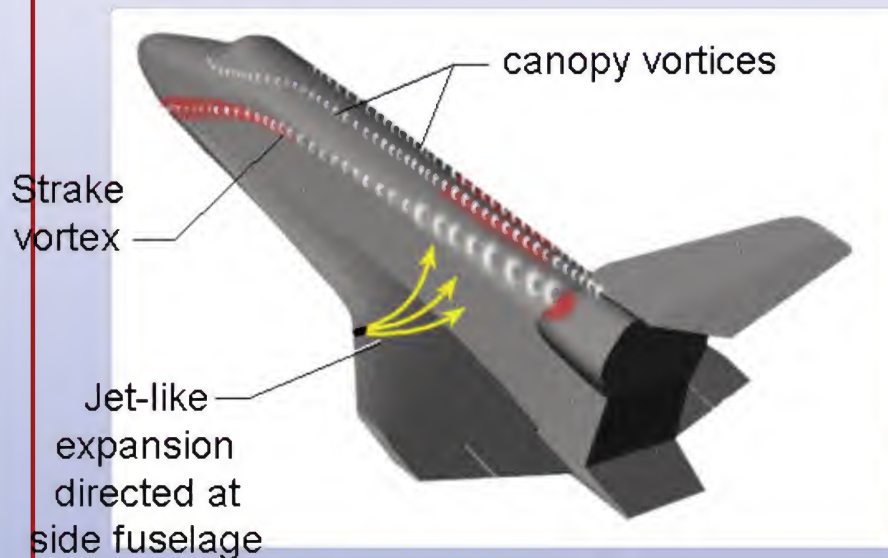
Conceptual sketch of Orbiter leeside flowfield

Effect of Missing RCC Panel on Orbiter Leeside Flowfield as Inferred From Surface Heating Patterns

Wing leading edge damage influences leeside flowfield

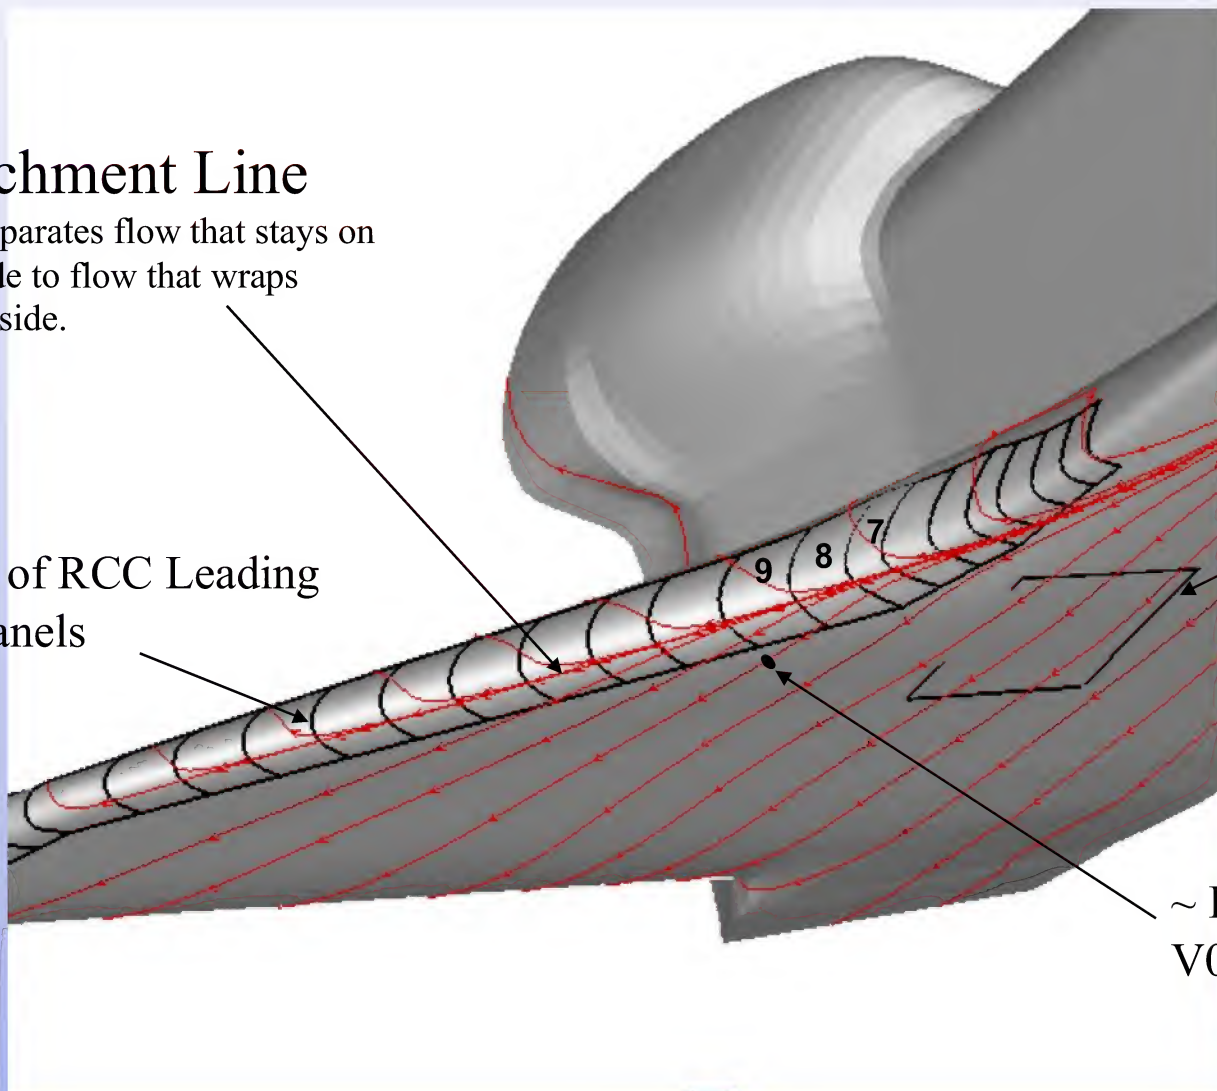
NASA Langley/(Gnoffo) Orbiter Surface Streamlines EI+404; Mach=24.9; Alt.=243k ft

- Line that separates flow that stays on windward side to flow that wraps around to leeward side.

~ Location of V07T9666A

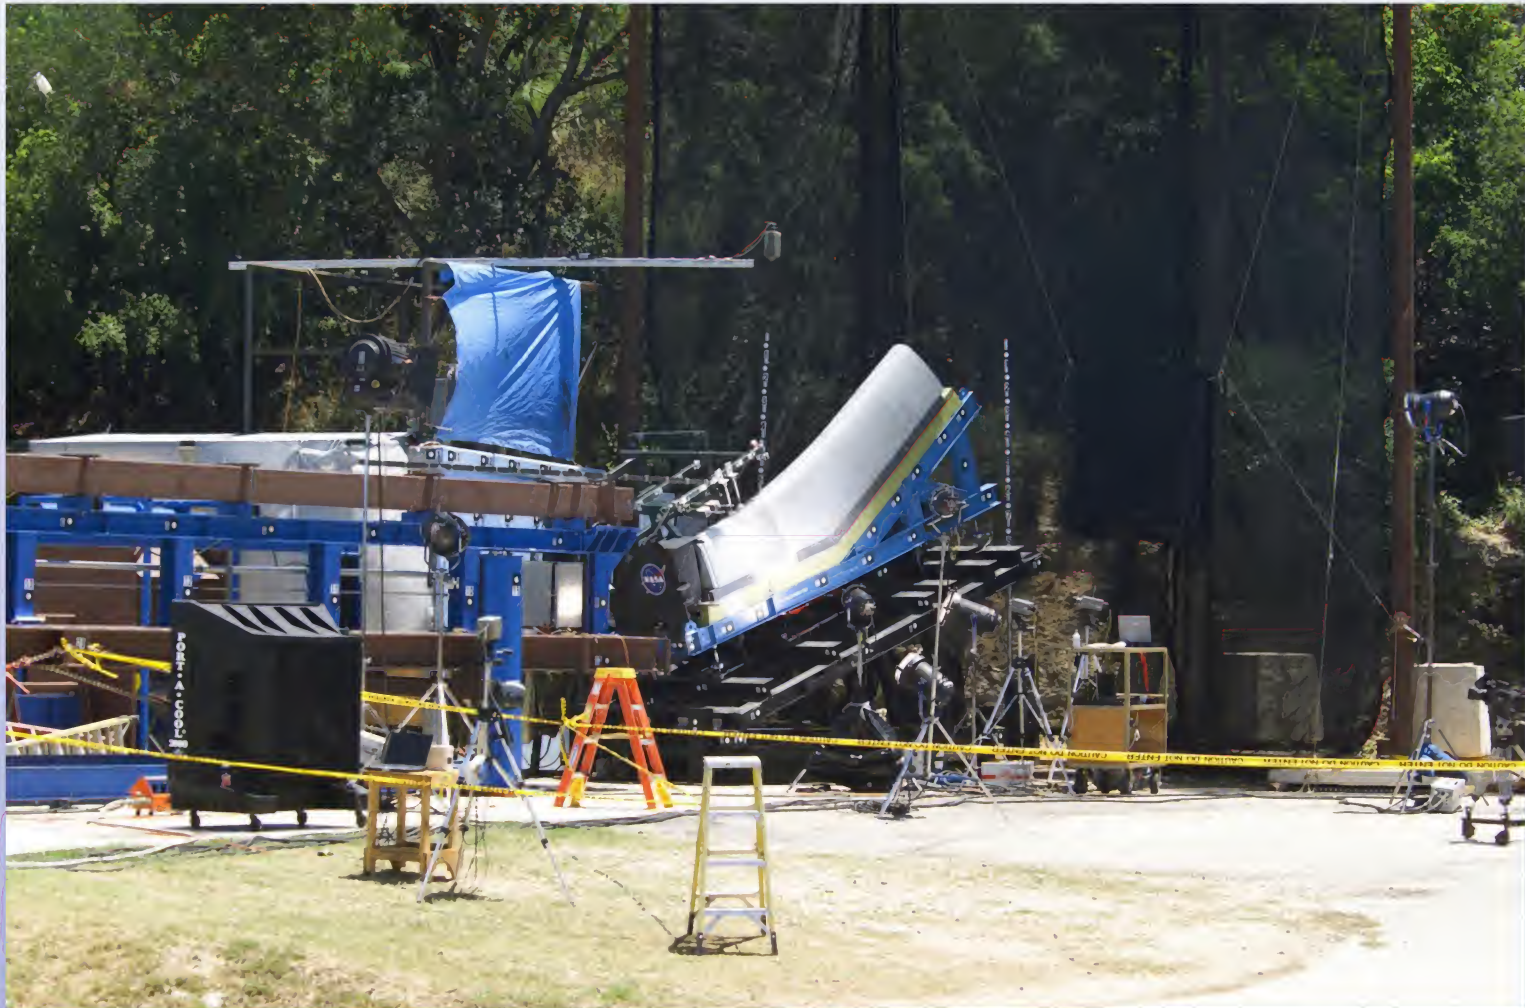
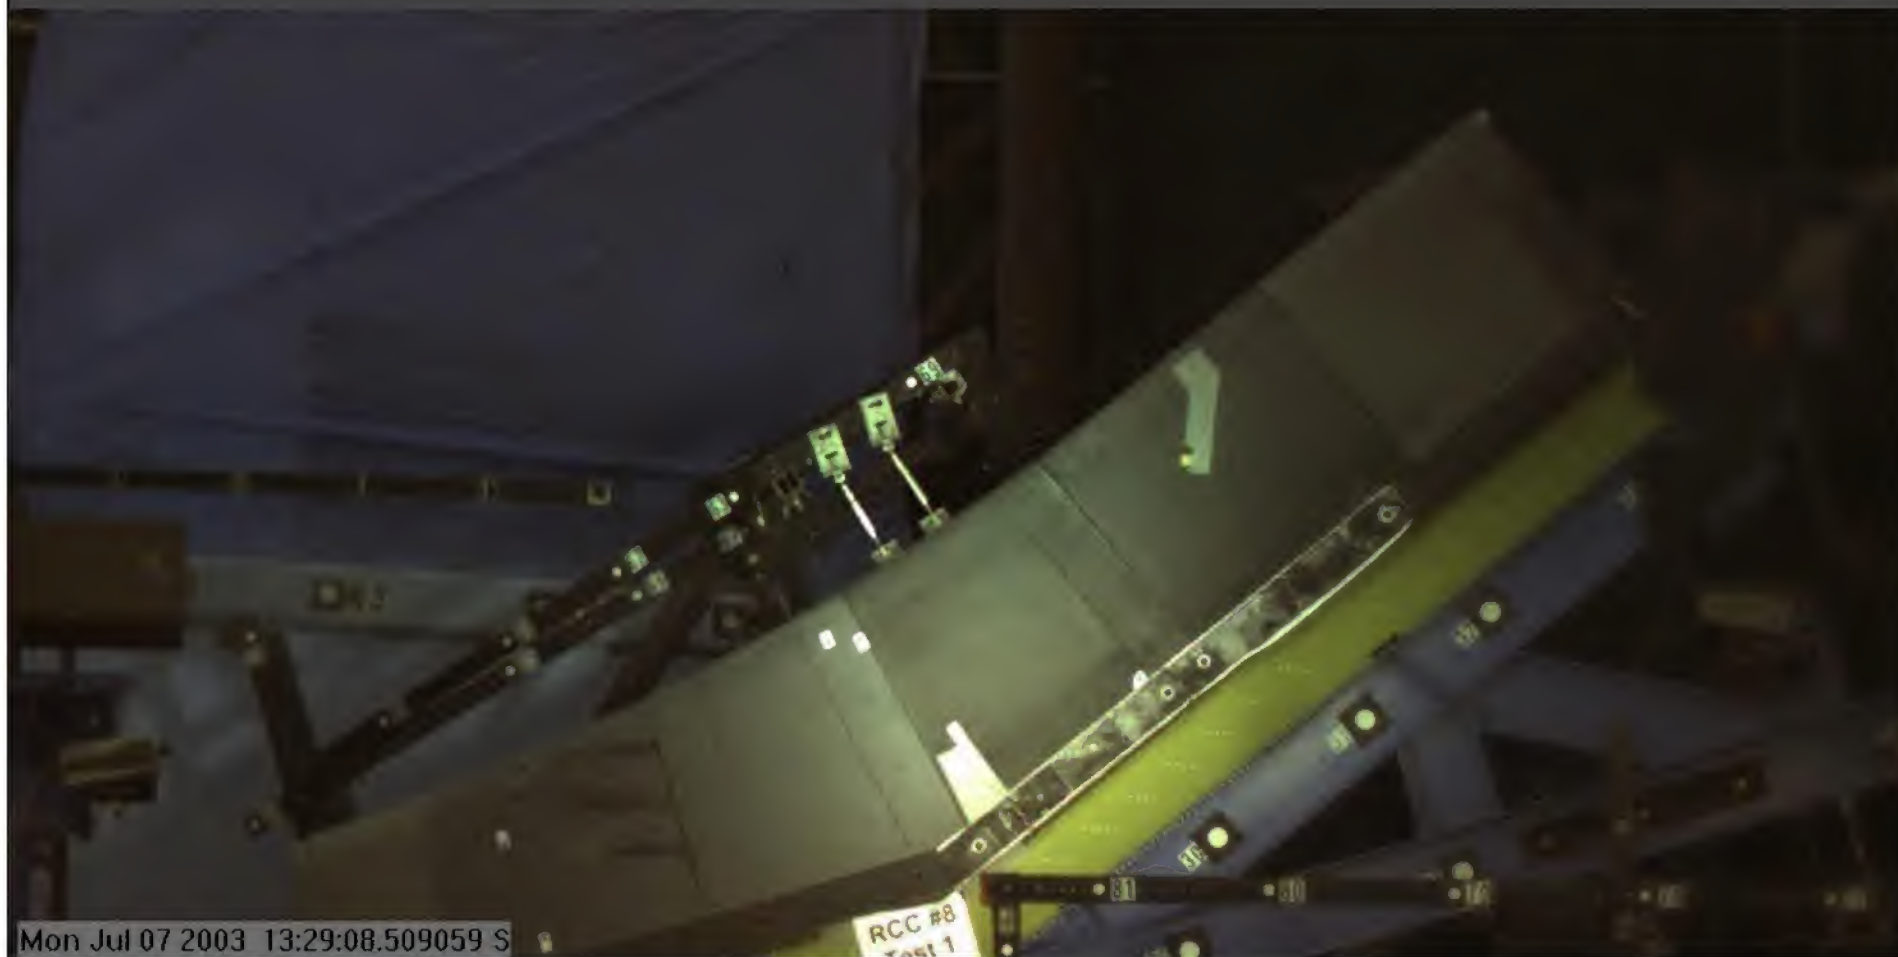
Wing Leading Edge Test Set Up

- CAIB lead: G. Scott Hubbard. Paul Wilde (CAIB) was lead on “Follow the Foam”. Large modeling effort led by JSC NASA and included work by Sandia
- Tests on tiles conducted first, little damage
- Then tests on fiberglass simulating RCC
- Tests on actual, aged RCC in one-for-one ground test
- Conclusive evidence that foam impact was initiating event
